Troubleshooting of Siemens Drives in Engineering Applications

This article describes some of the main alarms and faults generated by Siemens MASTERDRIVES 6SE70 series drives in engineering project applications and the handling process for these faults and alarms.

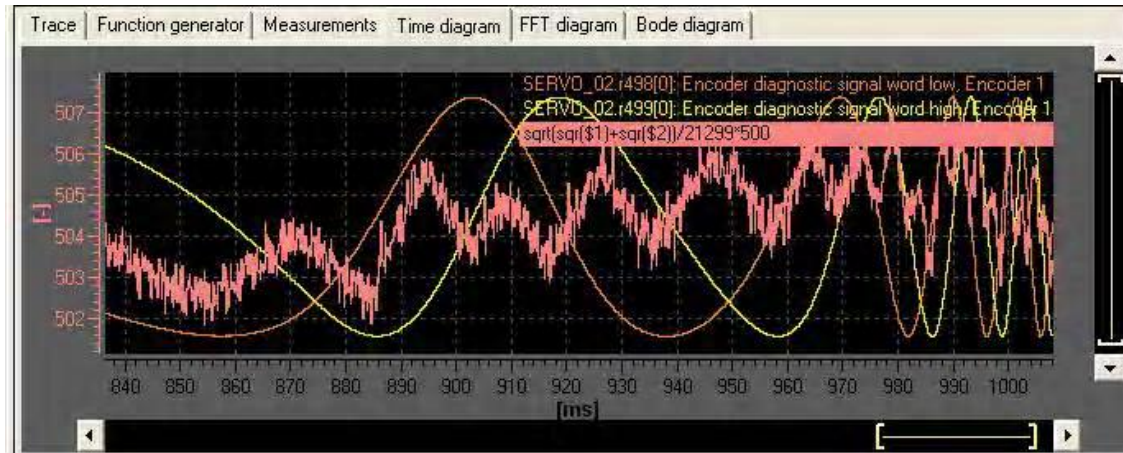
Figure 3. Encoder signal monitoring - frequency converter not enabled.

When the frequency converter does not provide an enable signal, the encoder recording curve obtained by manually selecting the motor is shown in **Figure 3**.

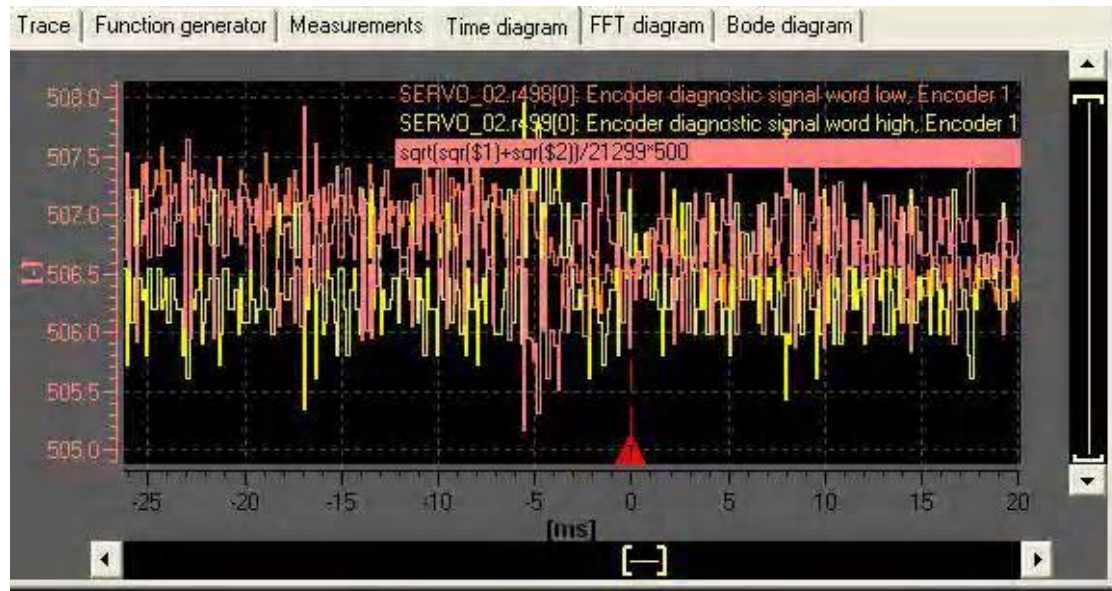
Figure 4. Encoder curve monitoring - under inverter enabling conditions.

Provide the enable signal of the frequency converter and record the encoder curve obtained as shown in **Figure 4**.

Through curve recording, it was confirmed that the fault was caused by an encoder problem. Upon careful inspection of the encoder wiring, there were no issues. Further inspection of the encoder revealed that the encoder fixture had some deformation. After communicating with the operator, it was learned that this week, the on-site assembly personnel accidentally smashed the universal coupling onto the encoder while lifting the universal coupling, causing the fixture to deform and causing the frequency converter to frequently report F006 faults.

(5) Result feedback. After replacing the encoder, the system is running normally and has been running normally for 8 months so far. The built-in trace function of DriveMonitor is like a recorder that accurately records some phenomena when a fault occurs, so it is important to make good use of the trace function to achieve the effect of “knowing the way and using it ingeniously”.

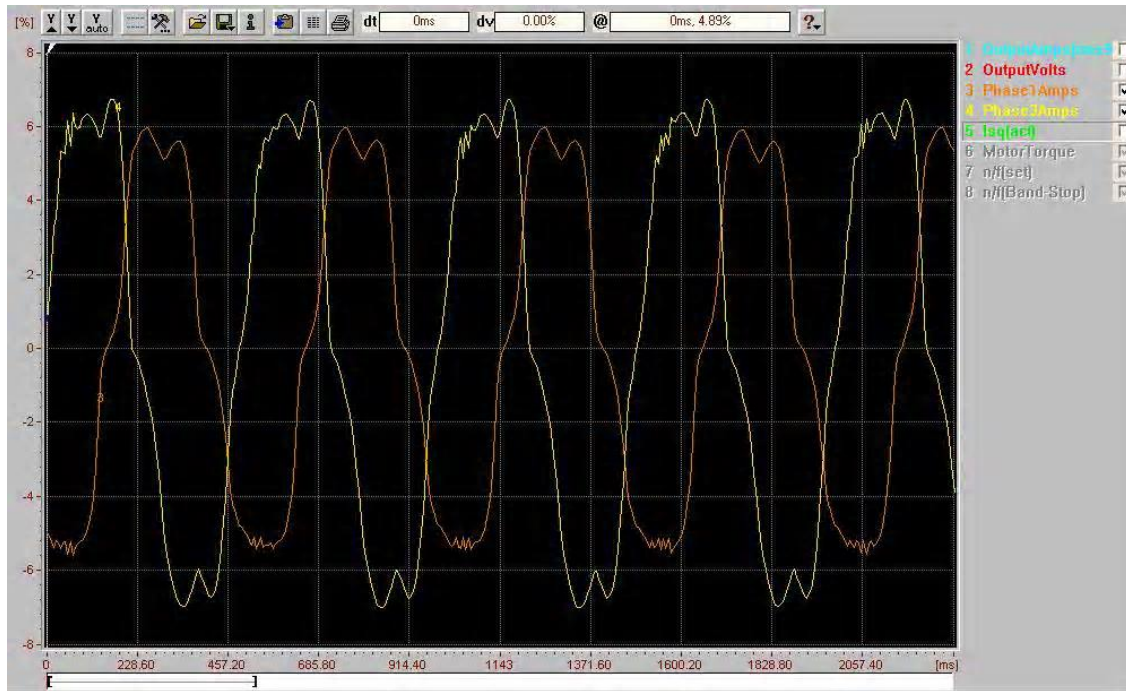
Figure 6. Output current waveform of frequency converter.

When the frequency converter that has reported a fault is running, use the trace function of Drive Monitor to record the current waveform. The specific situation is recorded as shown in **Figure 6**.

From **Figure 6**, it can be seen that the 1st and 3rd phase current waveforms output by the frequency converter are distorted, and there is also a difference in the amplitude of the two-phase current. It is likely that this distorted waveform has caused motor noise and vibration on-site. Due to the malfunction of individual cabinets, it is not possible to use the trace function of Drive Monitor to monitor each individual cabinet. A clamp ammeter was borrowed on site to detect the output current of each slave cabinet during motor operation. Firstly, a 4-parallel cabinet (P848.1=255) was used to start the motor with current compensation function (P848.4=255). The specific measurement data is shown in **Table 1**.

By comparing the above tables, it can be seen that when the system is equipped with current compensation function, the total three-phase current is approximately balanced. However, upon inspection of each individual cabinet, it was found that the three-phase current is severely unbalanced. Multiple combinations were attempted and the results were almost the same. Finally, by modifying the parameters, the current compensation function was cancelled, and it was found that both the individual cabinet and the total three-phase current are balanced. From this, it can be seen that the problem is still unclear. We request service personnel to bring oscilloscopes and other equipment to the site for more careful inspection work.

(4) Handling on-site issues. The first thing that came to mind was to replace the CUVC control board. Even after the replacement, the problem persisted. Then, we replaced the IMPI board and measured it. The problem did not change. At the same time, we also used a test box to test a single electrical cabinet and checked

the CT of the current transformer, but there were no problems. Then consider replacing the IN/OUT board used to transmit trigger signals between cabinets. After replacement, it was found that the problem was eliminated and the IN/OUT board was basically locked. However, there were not enough IN/OUT boards on site for replacement, so the current compensation function could only be temporarily cancelled. After the subsequent IN/OUT board arrives at the site and is replaced, the system has been running for almost a year without any problems.

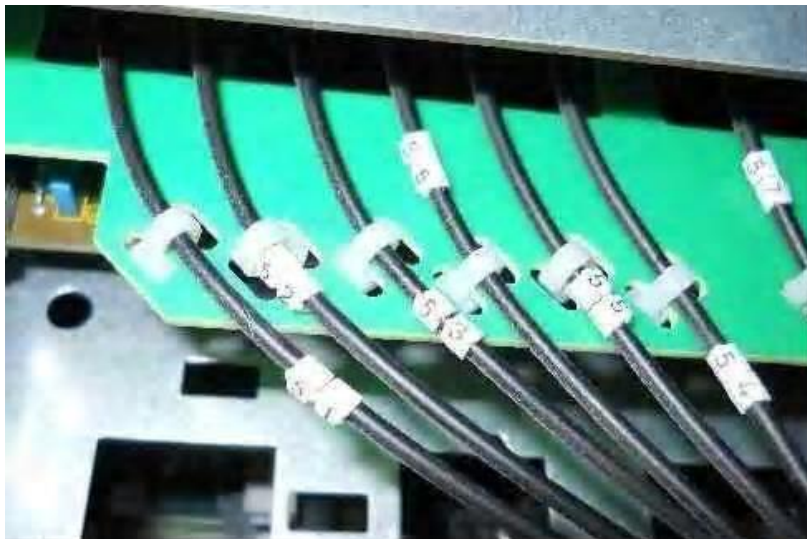
Figure 7. Fiber optic wiring diagram of frequency converter IN/OUT board.

The reason for listing the F011 fault again is because the reasons for the two faults are different. This time, the situation is as follows: the frequency converter is $4 * 1000\text{kW}$, and the motor is 3600kW . At the beginning of motor optimization, the F011 fault was reported. Upon inspection of the frequency converter, it was found that the fiber optic sequence on the IN/OUT board was mistakenly connected by the SEDL electrical cabinet factory, as shown in **Figure 7**.

From the figure, it can be seen that the fiber optic cables used to transmit IGBT trigger pulses are connected in the wrong order, and the fiber optic cables numbered 54 and 56 are connected incorrectly. After the changes are made, the motor optimization work is carried out again, and everything is normal.

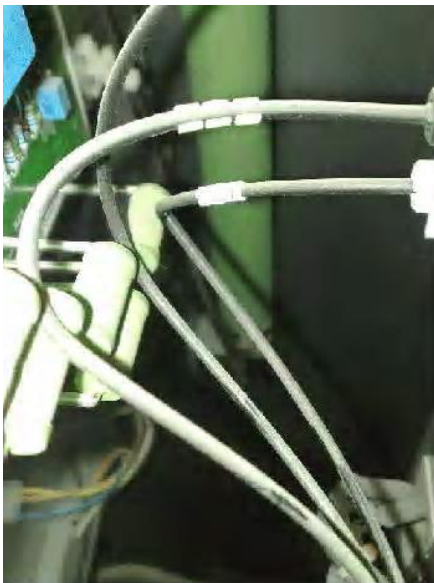
Figure 17. Trigger fiber optic lapping to resistance.

(3) On site problem analysis. Check the frequency converter, first of all, the CUVC control board. If a new CUVC board is replaced, the alarm still persists. Further inspection inside the frequency converter revealed that a fiber optic cable had come into contact with the resistance on the voltage distribution board on the side of the frequency converter. Upon closer inspection, it was found that the black sheath of the fiber optic cable had been scorched by the resistance. Turning off the lighting, red light could be seen on the fiber optic cable at that location. The problem should have been caused by the frequency converter factory's failure to fully consider during assembly. The fiber optic cable was replaced and kept away from the resistance. The specific situation is recorded in **Figures 17 and 18**.
