# Troubleshooting of Siemens Drives in Engineering Applications

This article describes some of the main alarms and faults generated by Siemens MASTERDRIVES 6SE70 series drives in engineering project applications and the handling process for these faults and alarms.

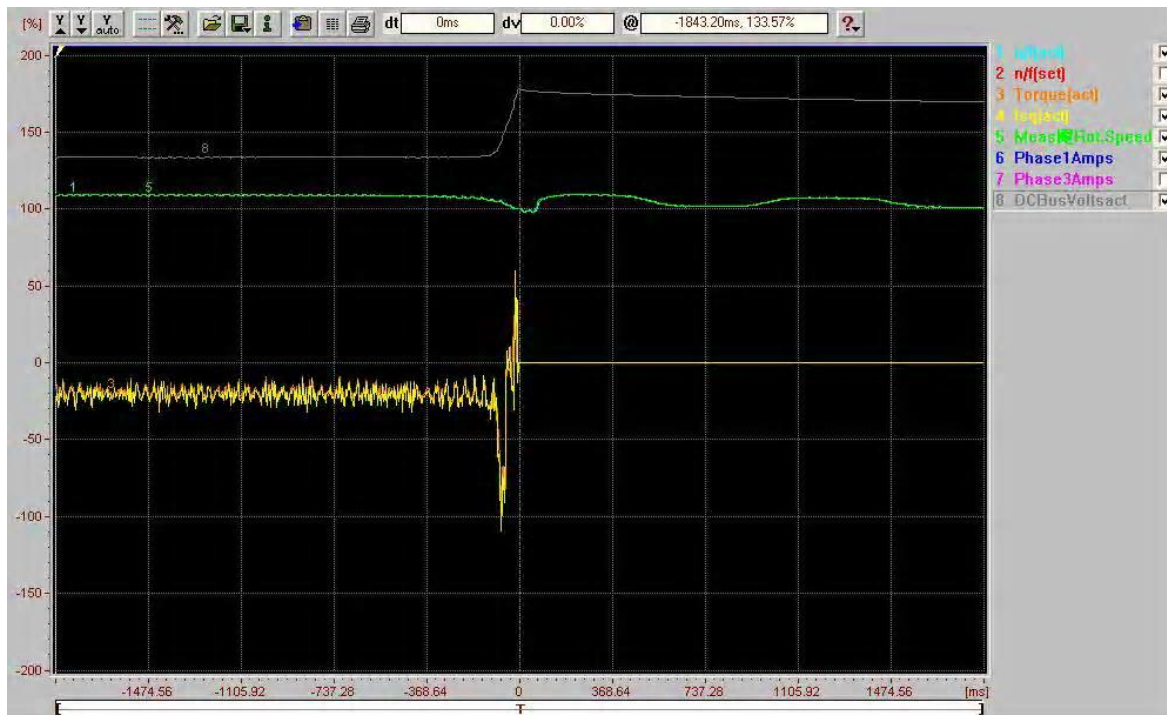
Figure 2. DC bus Yao encoder curve monitoring.

(3) On site problem analysis. Only by understanding the phenomenon when the fault occurs can targeted analysis be carried out and solutions be provided. Therefore, the trace function of DriveMonitor is first used to record some states when the fault occurs, and the fault triggers the trace function. The specific situation is recorded as shown in **Figure 2**.

(4) Handling on-site issues. From the results obtained from the on-site trace, it can be seen that there was a sudden increase in the voltage of the DC bus when the fault occurred. What is the reason for this change in the DC bus? Upon careful analysis, it was found that there was a sudden change in the actual value of the motor speed at this time, and it is suspected that the problem lies with the motor encoder. Using the service level permissions of the frequency converter to collect the output curve of the encoder involves the encoder reading parameters r498 and r499 of the frequency converter. Using the collected encoder data for calculation, the specific formula is as follows:

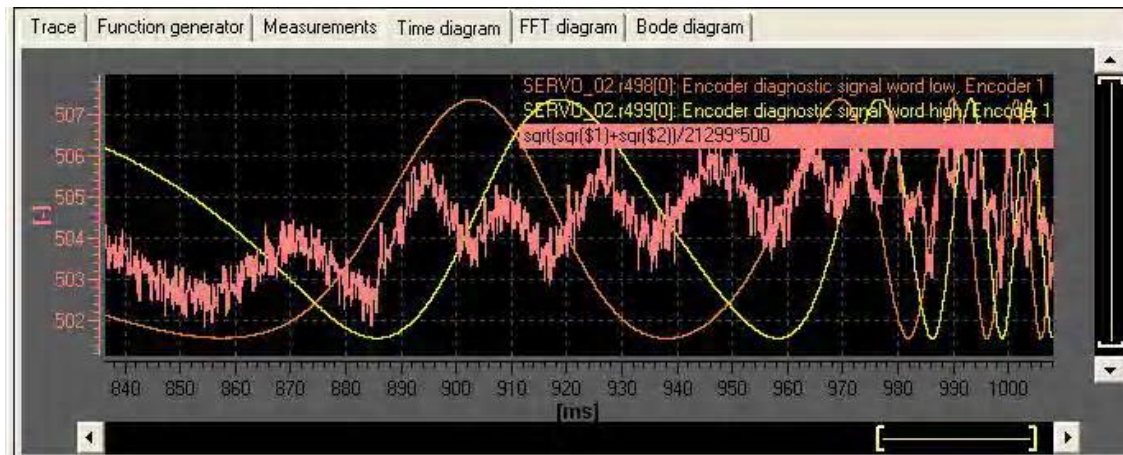
Figure 3. Encoder signal monitoring - frequency converter not enabled.

When the frequency converter does not provide an enable signal, the encoder recording curve obtained by manually selecting the motor is shown in **Figure 3**.

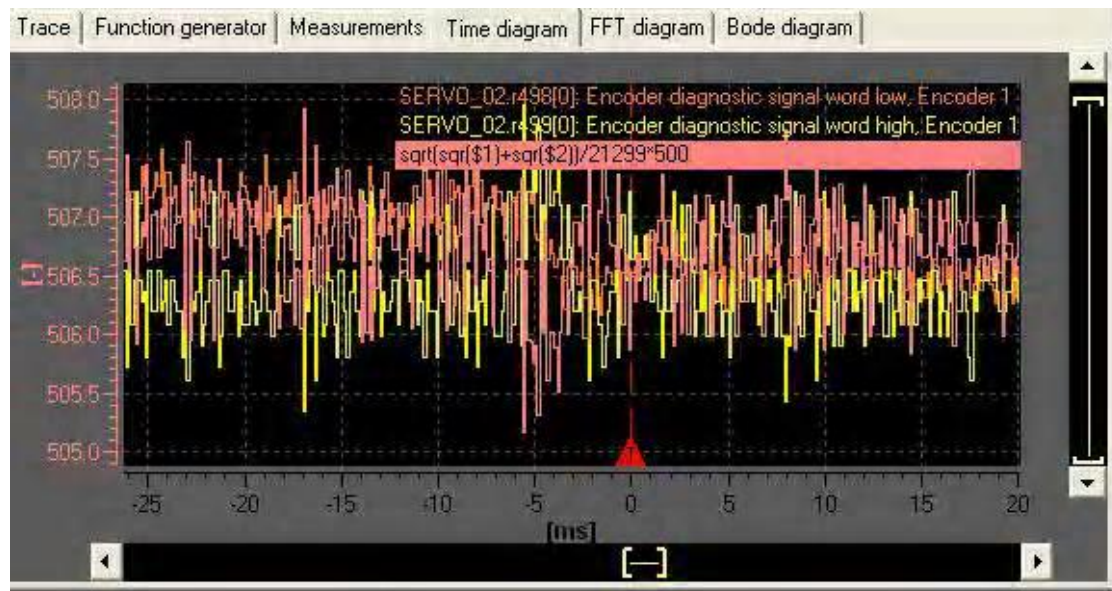
Figure 4. Encoder curve monitoring - under inverter enabling conditions.

Provide the enable signal of the frequency converter and record the encoder curve obtained as shown in Figure 4.

Through curve recording, it was confirmed that the fault was caused by an encoder problem. Upon careful inspection of the encoder wiring, there were no issues. Further inspection of the encoder revealed that the encoder fixture had some deformation. After communicating with the operator, it was learned that this week, the on-site assembly personnel accidentally smashed the universal coupling onto the encoder while lifting the universal coupling, causing the fixture to deform and causing the frequency converter to frequently report F006 faults.

(5) Result feedback. After replacing the encoder, the system is running normally and has been running normally for 8 months so far. The built-in trace function of DriveMonitor is like a recorder that accurately records some phenomena when a fault occurs, so it is important to make good use of the trace function to achieve the effect of “knowing the way and using it ingeniously”.

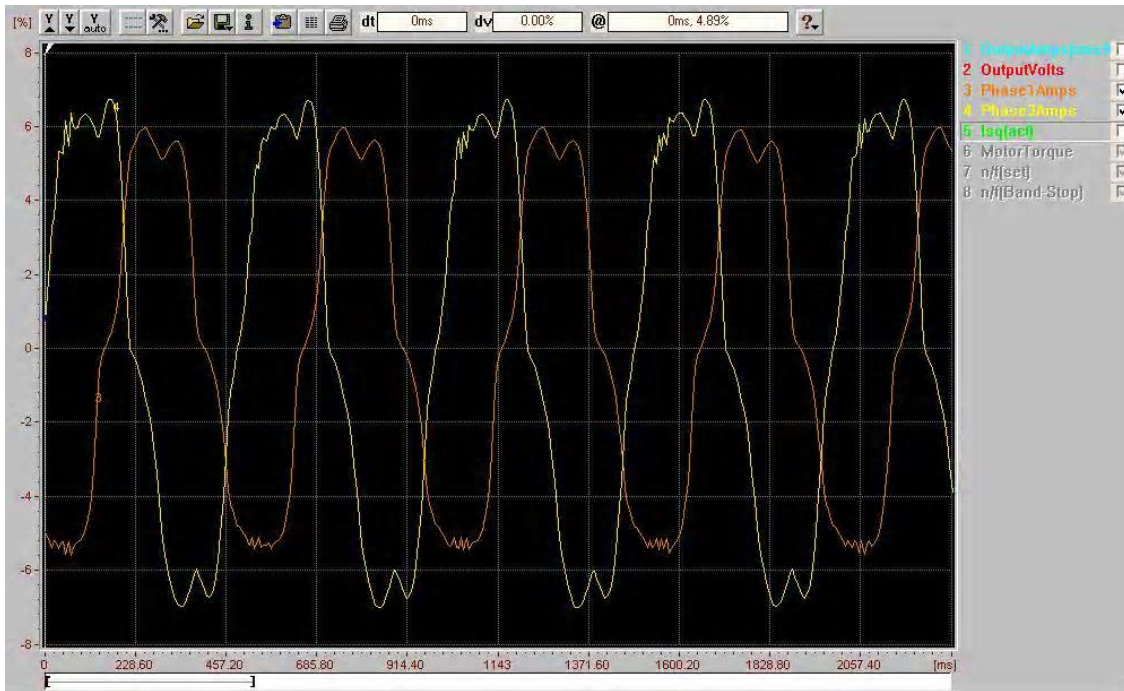
Figure 6. Output current waveform of frequency converter.

From **Figure 6**, it can be seen that the 1st and 3rd phase current waveforms output by the frequency converter are distorted, and there is also a difference in the amplitude of the two-phase current. It is likely that this distorted waveform has caused motor noise and vibration on-site. Due to the malfunction of individual cabinets, it is not possible to use the trace function of Drive Monitor to monitor each individual cabinet. A clamp ammeter was borrowed on site to detect the output current of each slave cabinet during motor operation. Firstly, a 4-parallel cabinet (P848.1=255) was used to start the motor with current compensation function (P848.4=255). The specific measurement data is shown in **Table 1**.

By comparing the above tables, it can be seen that when the system is equipped with current compensation function, the total three-phase current is approximately balanced. However, upon inspection of each individual cabinet, it was found that the three-phase current is severely unbalanced. Multiple combinations were attempted and the results were almost the same. Finally, by modifying the parameters, the current compensation function was cancelled, and it was found that both the individual cabinet and the total three-phase current are balanced. From this, it can be seen that the problem is still unclear. We request service personnel to bring oscilloscopes and other equipment to the site for more careful inspection work.

After the service personnel arrived at the site, they used an oscilloscope to monitor the current of the frequency converter and repeated the above steps several times to analyze that the problem may be in the current measurement detection and calculation circuit.

(4) Handling on-site issues. The first thing that came to mind was to replace the CUVC control board. Even after the replacement, the problem persisted. Then, we replaced the IMPI board and measured it. The problem did not change. At the same time, we also used a test box to test a single electrical cabinet and checked

the CT of the current transformer, but there were no problems. Then consider replacing the IN/OUT board used to transmit trigger signals between cabinets. After replacement, it was found that the problem was eliminated and the IN/OUT board was basically locked. However, there were not enough IN/OUT boards on site for replacement, so the current compensation function could only be temporarily cancelled. After the subsequent IN/OUT board arrives at the site and is replaced, the system has been running for almost a year without any problems.

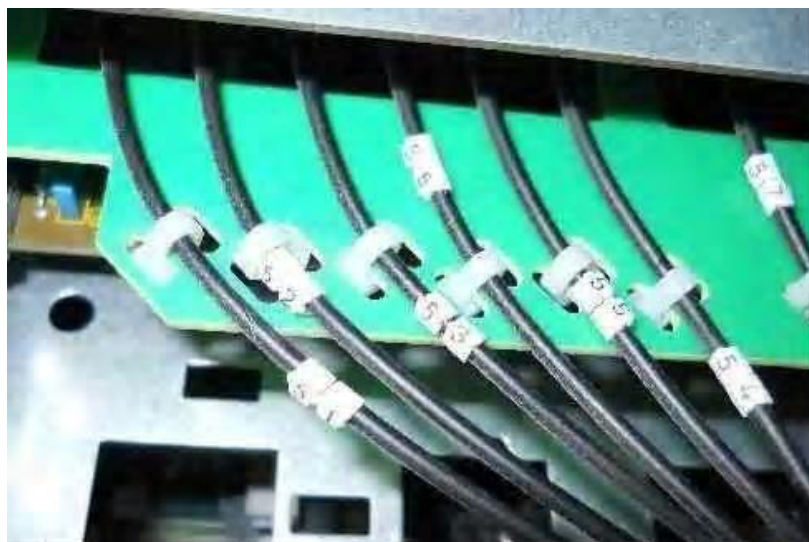
**Figure 7.** Fiber optic wiring diagram of frequency converter IN/OUT board.

The reason for listing the F011 fault again is because the reasons for the two faults are different. This time, the situation is as follows: the frequency converter is 4 \* 1000kW, and the motor is 3600kW. At the beginning of motor optimization, the F011 fault was reported. Upon inspection of the frequency converter, it was found that the fiber optic sequence on the IN/OUT board was mistakenly connected by the SEDL electrical cabinet factory, as shown in **Figure 7**.

From the figure, it can be seen that the fiber optic cables used to transmit IGBT trigger pulses are connected in the wrong order, and the fiber optic cables numbered 54 and 56 are connected incorrectly. After the changes are made, the motor optimization work is carried out again, and everything is normal.

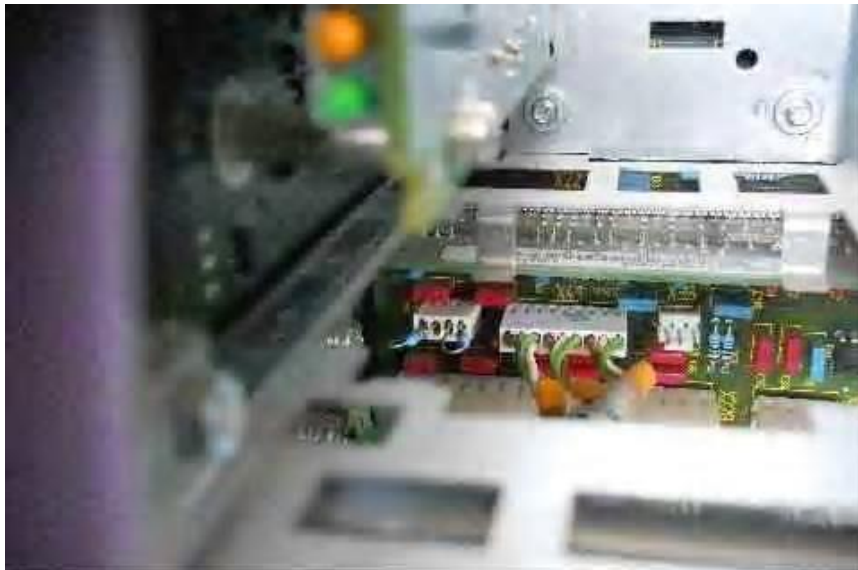
**Figure 9.** Inverter IMPI board.

(3) On site problem analysis. When using Drive Monitor to monitor the parameters of the frequency converter, it was found that when the frequency converter reported an F023 fault, the temperature of the frequency converter was around  $40^{\circ}\text{C}$ . Under normal circumstances, it should be around  $70^{\circ}\text{C}$  before the F023 fault was reported. There may be two possible causes of the malfunction, one of which is a problem with the NTC temperature sensor; The second issue is that there is a problem with the measurement and processing circuit. The NTC temperature sensor has been replaced before, but the fault still persists. The problem is likely caused by the measurement and processing circuit. The temperature processing is mainly related to the CUVC control board and IMPI temperature acquisition board. After replacing the CUVC board and IMPI board, the fault will still occur as scheduled. The problem was previously escalated to Siemens Germany headquarters, but no clear solution has been provided, and only a roundabout approach can be used to solve the problem.

(4) Handling on-site issues. The temperature collection of the frequency converter uses NTC thermistors. To address this specific situation, the following methods are used: 1) Connect the NTC temperature sensor to the SIEMENS analog template for collection. As the resistance value of the NTC temperature sensor is around  $\text{k}\Omega$ , in order to adapt to the range of the analog template, a fixed value resistor of about  $600\Omega$  needs to be

connected in parallel for the NTC temperature sensor. The PLC program is used to collect the temperature of the NTC sensor and make corresponding fault and alarm processing based on the collected temperature to ensure the safe operation of the frequency converter; The temperature calculation formula for NTC thermistor is  $R_t = R * \text{EXP} (B * (1/T_1 - 1/T_2))$ . T1 and T2 refer to K degrees, Kelvin temperature; B is the main parameter of a thermistor; Convert the above formula into a PLC control logic program to achieve temperature acquisition of the frequency converter. 2) Connect a fixed value resistor with a resistance value of around 4.7kΩ to the temperature acquisition input terminal of the IMPI board, with the intention of making the frequency converter control system believe that the temperature of the frequency converter is about 45°C and remains constant. This can prevent the frequency converter from misreporting F023 faults.

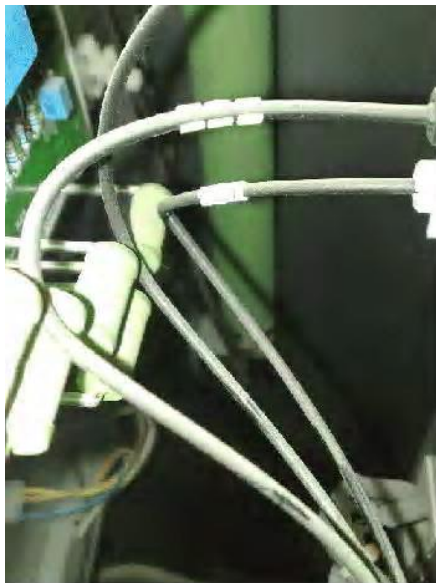
**Figure 17.** Trigger fiber optic lapping to resistance.

(3) On site problem analysis. Check the frequency converter, first of all, the CUVC control board. If a new CUVC board is replaced, the alarm still persists. Further inspection inside the frequency converter revealed that a fiber optic cable had come into contact with the resistance on the voltage distribution board on the side of the frequency converter. Upon closer inspection, it was found that the black sheath of the fiber optic cable had been scorched by the resistance. Turning off the lighting, red light could be seen on the fiber optic cable at that location. The problem should have been caused by the frequency converter factory's failure to fully consider during assembly. The fiber optic cable was replaced and kept away from the resistance. The specific situation is recorded in **Figures 17 and 18**.
